Archie's New Bearing

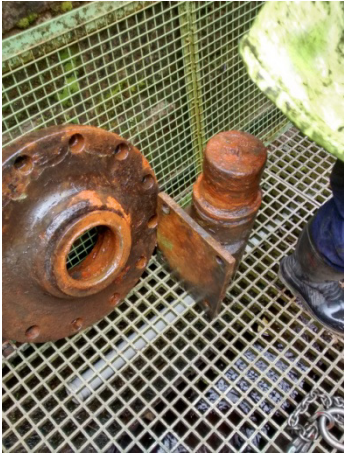
At an Open Day back in September 2015, we opened the sluice gate to demonstrate the screw turning. Something was clearly wrong – the screw turned a little and there was a horrible grinding noise. An expert inspection revealed that Archie's bottom bearing had failed. Unfortunately, this coincided with the autumn and winter rains, making it unsafe to work in the river until the water level dropped. During the winter of 2015/16 extensive discussions between the project engineers led to the development of a set of detailed plans regarding how best to install the new bearing. The first step involved the design and construction of a new guide trough to hold the new stop logs, which was necessary to enable the tailrace to be "dewatered" to allow access to the bearing. The months of careful planning paid off and as soon as the river dropped sufficiently and it was safe to go into the river the removal and installation of the new bearing was carried out by a combination of specialist contractors and our (very experienced) volunteers.

What metal looks like after 8 years in the river

In mid-June, we were finally able to replace the bottom bearing and install a new grease line to lubricate it. We also took the opportunity to change the gearbox oil, service the generator bearings, and replace a few bits and pieces that had come adrift over the years. As ever with these things, the conditions were appalling – rainy and cold, with knee-deep mud and river muck. A typical English summer, in other words!

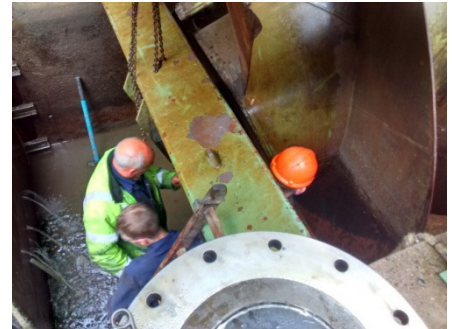
Work began at the end of May. Before the "real" work could commence, a huge amount of mixed silt had to be removed,

ranging from vegetable matter through sand and gravel up to boulders and stone blocks. Just seeing the stop boards in place and the area at the bottom of the screw free of silt in readiness for the engineering work gave everyone a major boost.

The crew at work

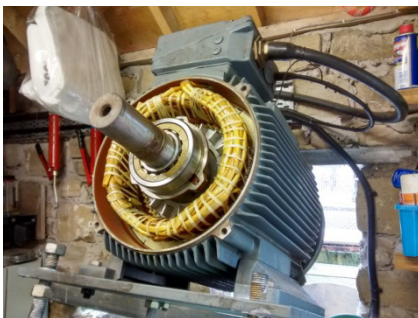
Archie's shiny new innards

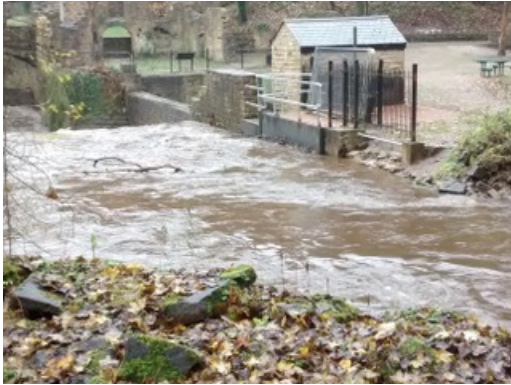
The river gods had not finished making our lives difficult though: the storms in November blocked the inlet yet again. The usual Monday morning check had left Archie spinning happily, but following some very localised heavy rains over the next 24 hours huge amounts of stone were deposited in front of the intake, completely blocking it. The scale of the problem became evident as the water levels finally went down. Silt had completely covered the inlet to Archie and the fish pass, as well as leaving a lot of debris elsewhere on the site. As our trusty band of volunteers once again rolled up their sleeves and inspected the mess it was clear that there were some very large stones mixed in with the usual bits of tree, etc, so it was felt that it would be quicker and safer to have the debris removed mechanically. This was quickly arranged and Archie was back in action only two days later.

Too much water in the river!

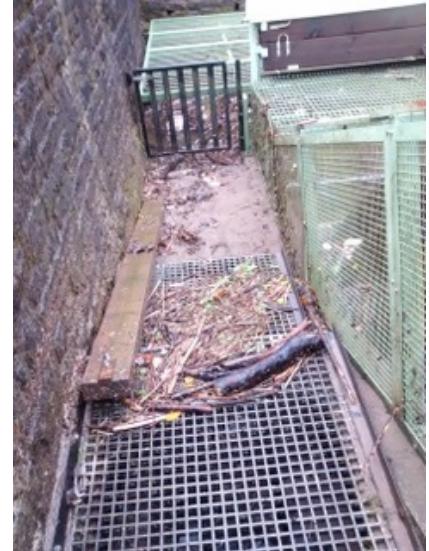
Debris on the fish pass steps
